SAS Superstructure

Daily Diary Report by Bid Item

Contract No.: 04-0120F4

04-0120F4
04-SF-80-13.2/13.9
Self-Anchored
Suspension Bridge

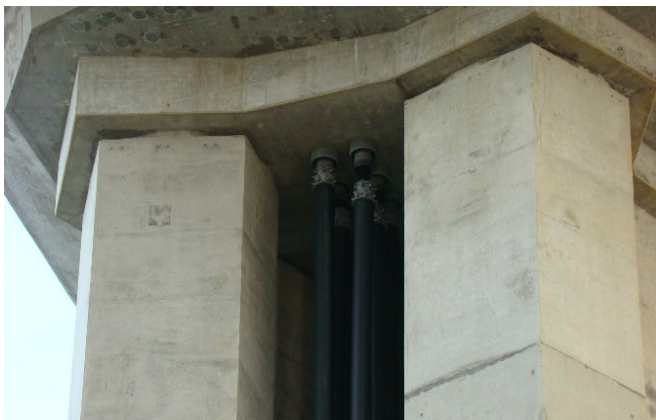
Another W2 cable tie-down (W-Line far SW pipe) HDPE cover which has slipped off of the bottom pipe.

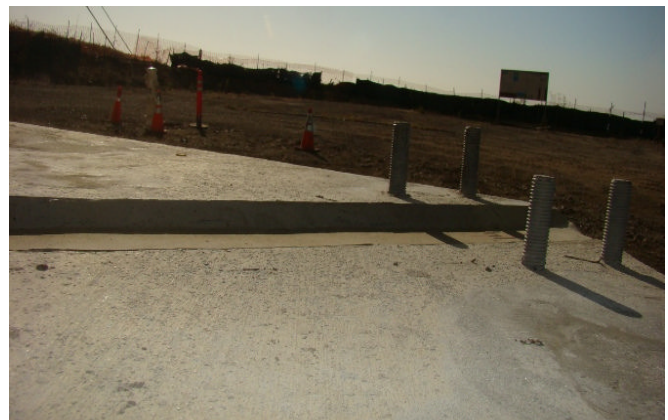
Difference in elevation of the W2 precast cover slab observed on the E-Line SW corner.

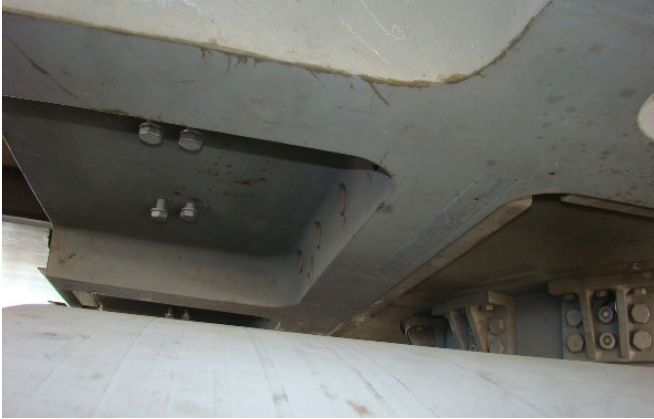
Plug bolts installed on the S2 Shear Key lower housing today.

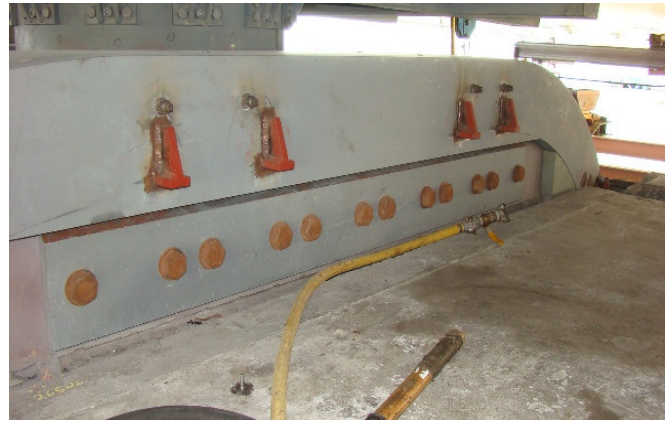
Rust on the S1 Shear Key retrofit south side plate bolts which needs to be painted by the Contractor.
